■ **GENERAL CHARACTERISTIC**

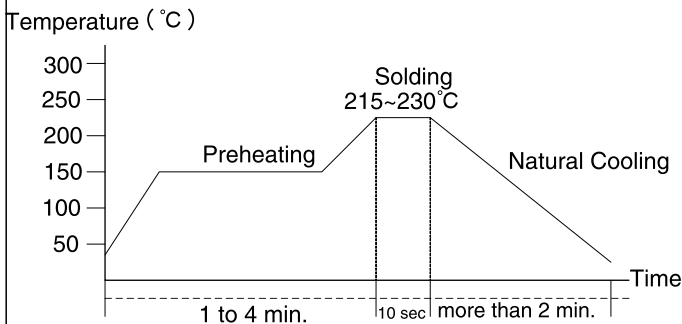
Led ed

A test is made under the above mentioned condition, and it is kept for 2 hours in the normal temperature and humidity. After that, no mechanical and electrical defect should be found.
